# Stingray

ATTACHMENT TOOL

## Specifications: (Stingray-1200)

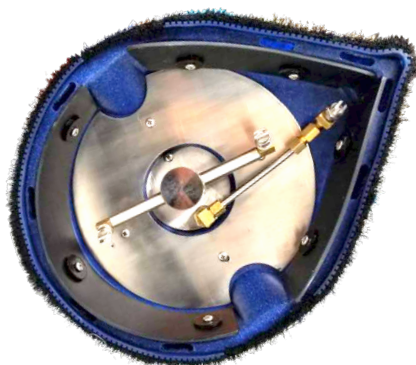
Bottom view of Stingray

Two rotating jets and one corner jet

Two rotating jets and One corner jet

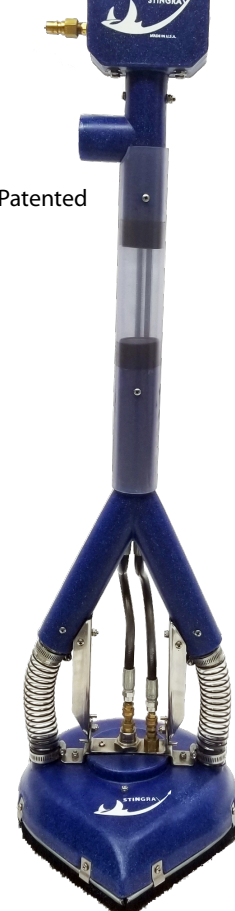
Right handle for the  
two rotating jets

Left handle for  
the corner jet

Comfortable pistol grips on handle assembly  
(The grips provide ease when working long hours)
